1958-64 Impala Front tubular upper control arm kit

Part # CTA-84A

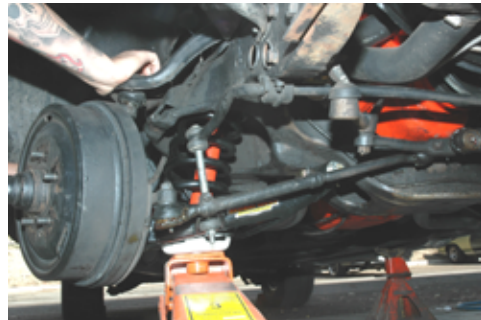
6. Slide the upper arm off the studs. If the steering shaft or headers are in the way. You will need to remove the serrated bolt / stud out of the frame. **Do not try to unscrew the studs or take an impact gun and blast them off the frame. You will damage the frame and the stud. You must press the stud straight out. We use a C clamp and socket.**

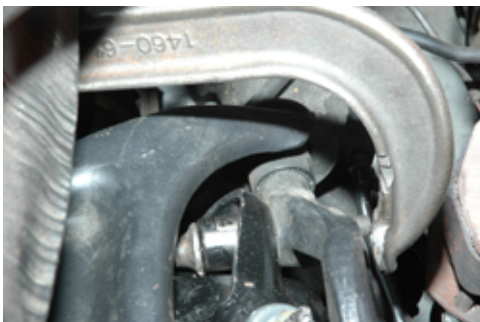
Place the 3/4 socket over the head of the bolt/stud and with a C clamp over the socket and stud, screw the C clamp together. The stud will pop out of the frame.

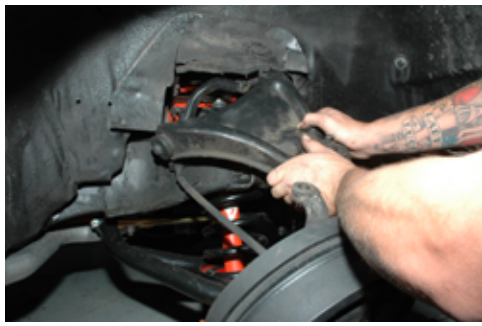
Note: When you reinstall the stud in the frame with the new upper arm. Make sure the stud is in the upper arm shaft, use a drift punch and drive the stud back into the frame.

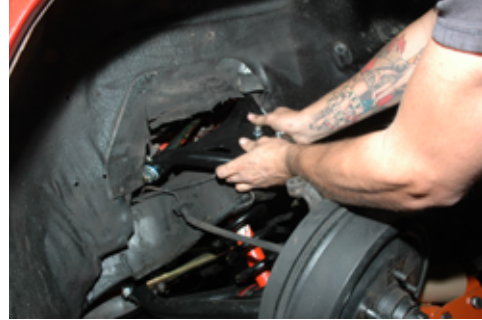
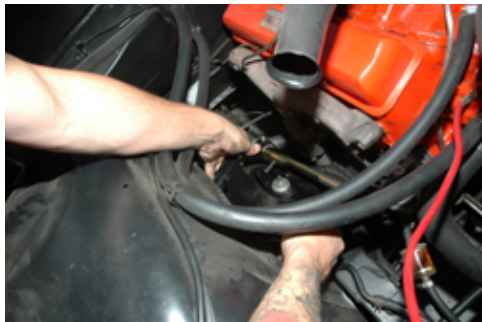
7. With the arm removed locate the correct upper control arm for the side you are working on. A fast reference is the upper bump stop goes towards the front of the car. By slightly angling the upper control arm through the inner fender well install the new upper control arm.
8. Slide the upper arm shaft over the frame studs. If you removed one or both of the studs, re-install them now.

Make sure the stud is in the upper arm shaft, use a drift punch and drive the stud back into the frame

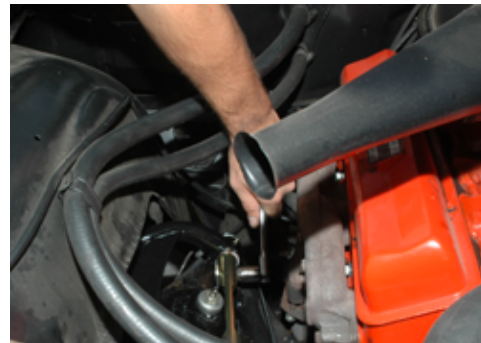
9. Install one 1/8- inch alignment shim on each bolt. The shims go between the frame and the upper shaft and then tighten down the bolts. **The shims supplied in the kit are not alignment shims (8). They are for upper arm shaft removal.**

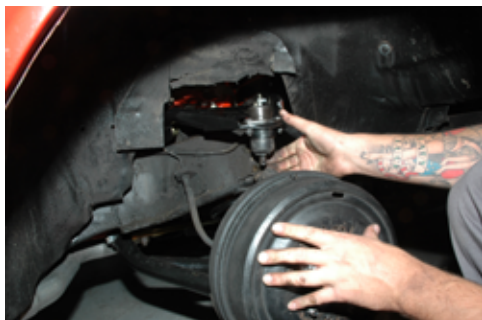
10. The next step will be installing the upper ball joint into the spindle. Tighten down the upper ball joint to the spindle and torque to 65 foot-pounds. Lubricate the upper ball joint after installation. The upper control arm bushings are already lubricated during assembly.

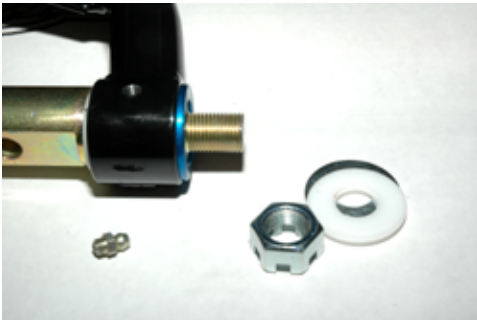
1. Remove the upper control arm cotter pin, nut, grease fitting and thrust washers from both sides of the control arm.

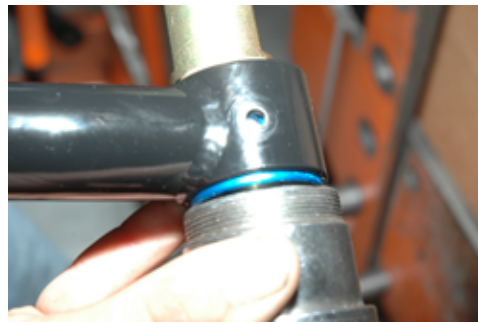
2. Locate a tube or housing of some kind that fits around the blue bushings in the arm.

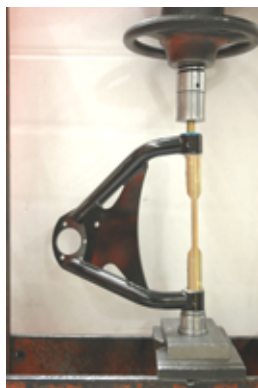
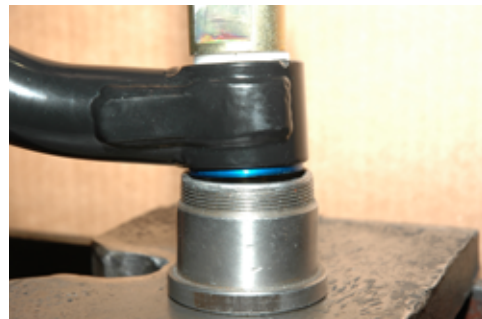
3. Place the control arm with the housing in the press so you can press against the shaft and push the blue bushing out.

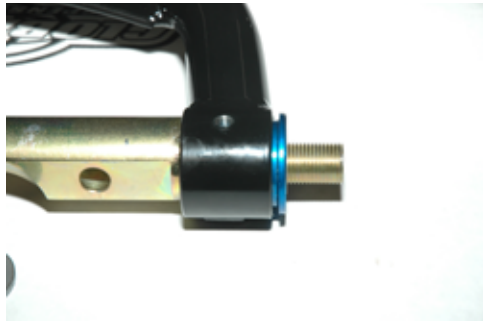
You will only be able to press about 1/8 inch before the shaft will bottom out on the arm. Press both bushings out of the arm 1/8 of an inch.

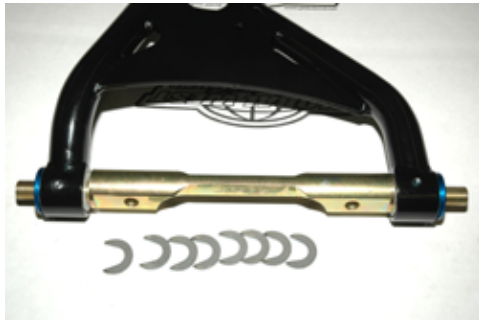
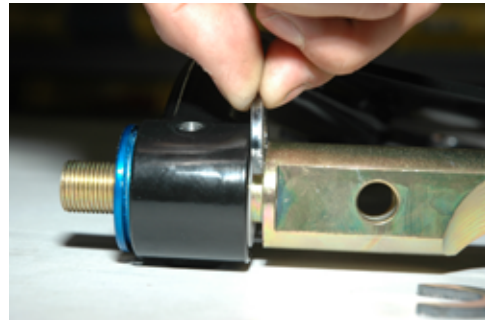
4. When both bushings are press out 1/8 of an inch, slide the shaft to one side, place one of the shims provided in your kit between the white plastic inner thrust washer and the shaft. You will only install the shims on one side.

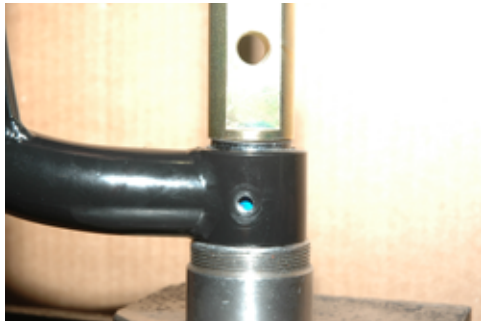
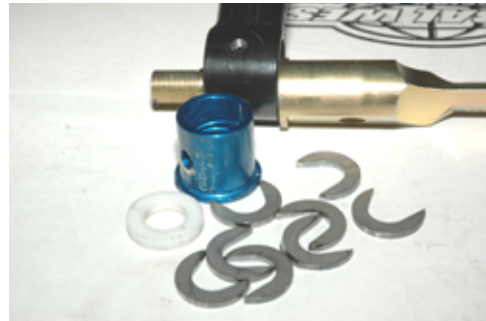
5. Place the arm back into the press and press the bushing with the steel shim out another 1/8 of an inch. Remove the arm from the press and slide the shaft up so you can install another shim against the previous. You will continue this process until all 8 shims are used. The bushing will then come out.

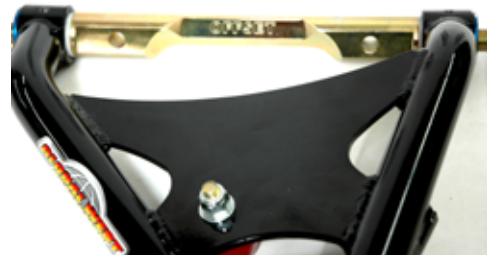
6. Slide the shaft out of the control arm and flip the shaft so the words engraved on the shaft saying (offset) are towards the engine. Note: The words should not be upside down looking at the top of the arm. You are now ready to reinstall the bushings.

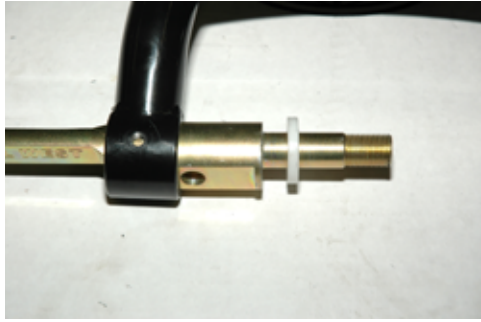
7. The white plastic thrust washer 1-1/4 od goes on the shaft first, **one on each side.**

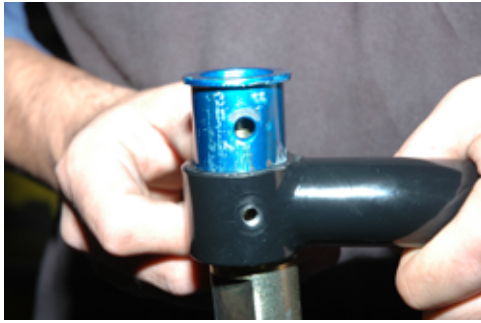
8. Press the blue bushing into the housing.
Important: Do not apply pressure across the control arm to press the bushings in. This will damage the control arm and void the warranty. Press the bushing into the housing by applying pressure only to the housing the bushing is going in to. See photo below.

Align the 2 holes up before pressing and press the bushing in. Flip the arm over and press the other bushing in as well.
