**Camaro / Firebird *TracLink***  
**TSC series (TSC-27)**  
**Installation Instructions**

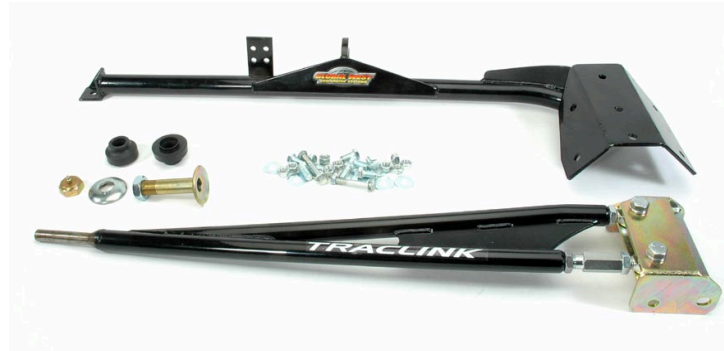
Kit provides:

- (2) - rubber bushings
- (1) - steel sliding sleeve with attached washer
- (1) - steel concave washer
- (1) - 1 inch x 14 jam nut
- (1) - end cap 1 inch x 14 jam with grease fitting
- (1) - torque arm assembled with:
  - (2) - 5/8 rod ends,
  - (1) - rear end bracket,
  - (1) - adjuster,
  - (2) - 5/8 x 18 bolts,
  - (2) - 5/8 lock washers,
  - (2) -right hand jam nuts,
  - (1) - left hand jam nut
- (1) - main support beam
- (8) - 1/2 x 20 lock nuts
- (7) - 1/2 x 20 x 1 grade 5 bolts
- (1) - 1/2 x 20 x 1-1/4 grade 5 bolt
- (7) - 1/2 uss flat washers
- (2) - 3/8 x 24 x 2 1/2 grade 5 bolts
- (4) - 3/8 flat washers
- (2) - 3/8 x 24 lock nuts
